Subject: Ferry Walla Walla 1A Propulsion Motor Incident

Engineering Investigation Report

WSDOT#01-2012

January 4, 2013

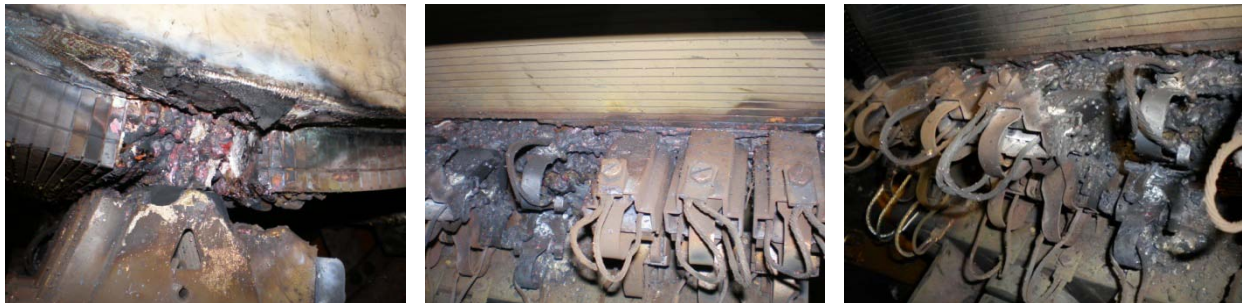
Figures 1-3

On November 4, 2012, the vessel Walla Walla was moored at Eagle Harbor Maintenance facility, undergoing propulsion system maintenance. The 1A propulsion motor suffered severe overheating and damage to its armature (see Figures 1, 2, and 3). This incident happened due to a breakdown in communication between the maintenance crew and vessel engineers, lack of system understanding and written procedures and an overly ambitious schedule, attempting to accomplish more than reasonably possible.

The 1A motor was scheduled to have maintenance done after the 2B stoning procedure was completed. Because two sets of brushes were left in their operational position, voltage was applied to the armature through the brushes while the A propulsion loop was energized and caused significant heat damage.

The Plexiglas covers were all in place on the 1A motor during this incident, containing all arcing that occurred. Because the covers were in place, it eliminated any safety concerns regarding adjacent equipment or personnel. There were no individuals in that space during this maintenance.

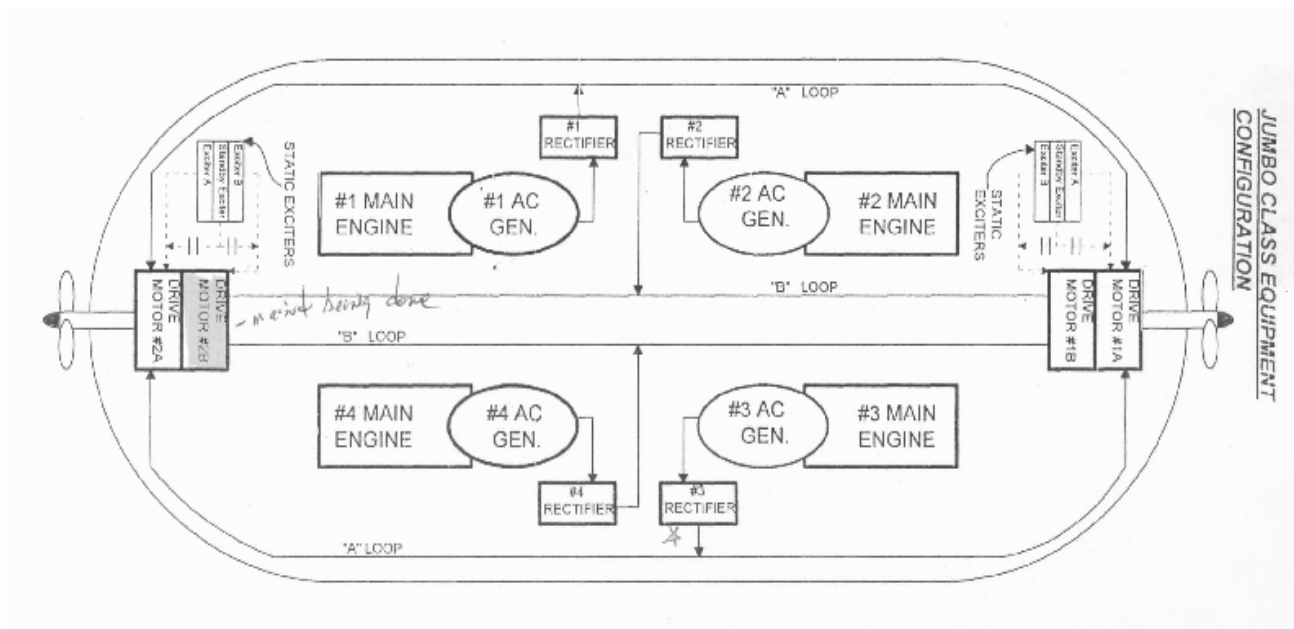
Figure 2

The figure above is being used to illustrate the electrical configuration of the Walla Walla. It is not intended for this diagram to depict the actual physical layout of the vessel. As shown in Figure 2, the Jumbo Class propulsion configuration (Walla Walla) is designed with two propulsion loops. The #3 Main Engine/Generator was providing power to the "A" loop, so that they could turn the #2B motor with the energized 2A motor that was assigned to the A loop. The brushes were all lifted on the 2B motor in order to hand stone the commutator.

The electricians assumed that with the excitation deenergized and tagged/locked out, the 1A motor which is also part of the A loop, would be OK while still in that loop.

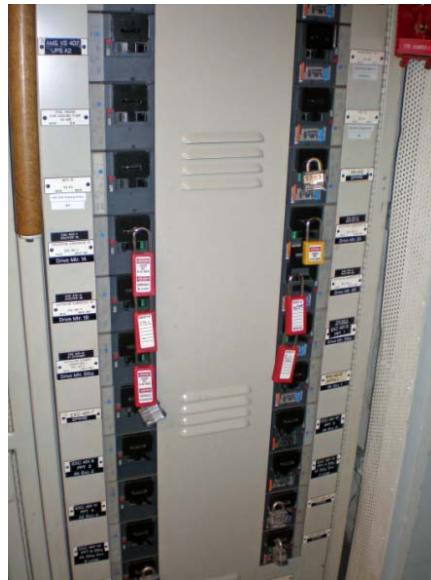
Figure 3

The Staff Chief Engineer, Bruce Cooper, opened all the switches for the 1A & 1B motor exciters, tagged and locked out the power to the exciter cabinets for the 1A & 1B motors; see Figure 3.

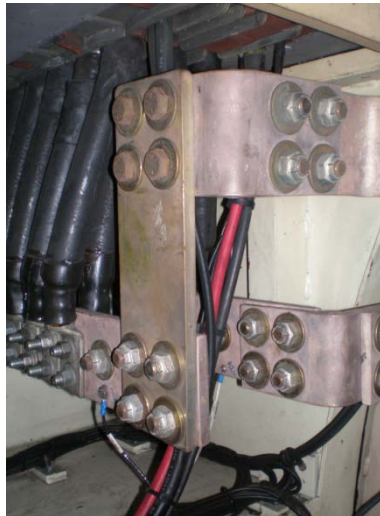
Because the propulsion motors on the Walla Walla are connected to each propulsion loop through bus links, the motors are not isolated from propulsion voltage when their respective exciters are taken out of service.

Figure 4 shows the links that are located in an enclosure which is attached to each motor. If a motor has to be isolated completely from the energized propulsion loop, these links must be removed and repositioned so that the loop stays closed, going around the motor circuit and isolating the motor armature from the loop voltage.

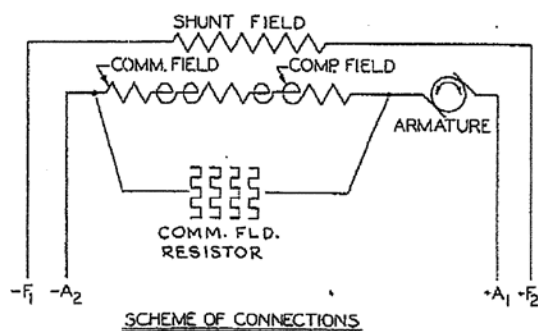
Figure 5

- Figure 5, shows that -- with the exciters secured and tagged out, if the propulsion A loop is energized, power is present at the A1 and A2 connections. Connections A1 and A2 can only be disconnected by opening the links as previously discussed.

- With only two sets of carbon brushes in place on the commutator and no excitation applied to the field (F1, F2) the motor would not develop enough torque to break free.

- We believe that the damaged brush set (negative polarity) initially had a higher resistance than the positive set. When the voltage was applied, current flowed through both brush sets; however, the higher resistance of the negative brushes caused it to more rapidly heat up. As its temperature increased over that of the positive set, its relative resistance increased as did the voltage across it. This heat-resistance relationship caused the negative brush set to reach the melting point of copper much faster than the positive brush set. The resulting arcing caused a reduction in the total current; and at that point, the positive brush set would have experienced decreasing heat dissipation and never reached the point of obvious damage.
